## Forensic Engineering Case

### ELECTROSURGICAL UNITS

By Matthew F. Baretich, P.E., Ph.D.

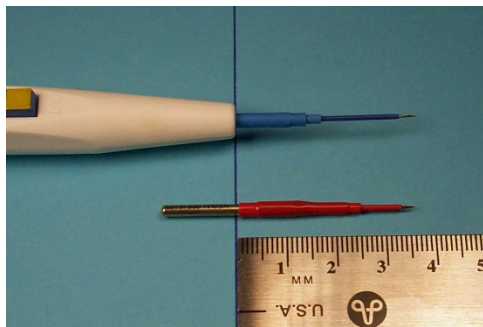
A problem we have seen multiple times is incomplete insertion of ESU electrodes (left). The result is that not all of the ESU current flows from the distal end (tip)

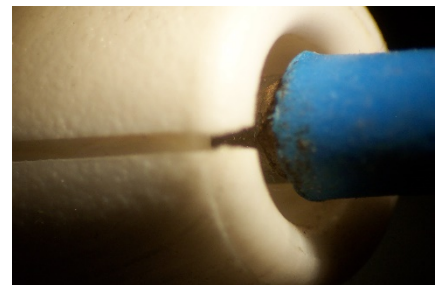
of the electrode, as intended, but also from the proximal end (near its insertion point, right), potentially causing tissue burns at unintended locations.

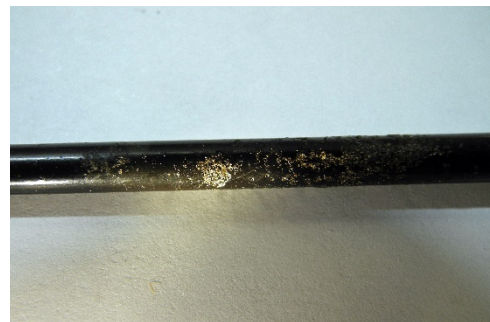
The possibility of inappropriately-located ESU current flow can become even more hazardous during laparoscopic procedures in which the surgeon has a limited field of vision and may be unable to immediately recognize the effect of inappropriate current flow. The surgeon's response to inadequate cutting or coagulation at the intended site may lead him or her to increase the ESU power setting, which can lead to greater tissue damage at the unintended site. The underlying cause may be failure of electrode insulation, which may be apparent upon visual inspection (right) or detectable only by insulation testing equipment.
